National Register of Historic Places Registration Form

historic name Anderson Downtown Historic District

Section number 7 Page 1 *Anderson Downtown Historic District, Madison County, IN*

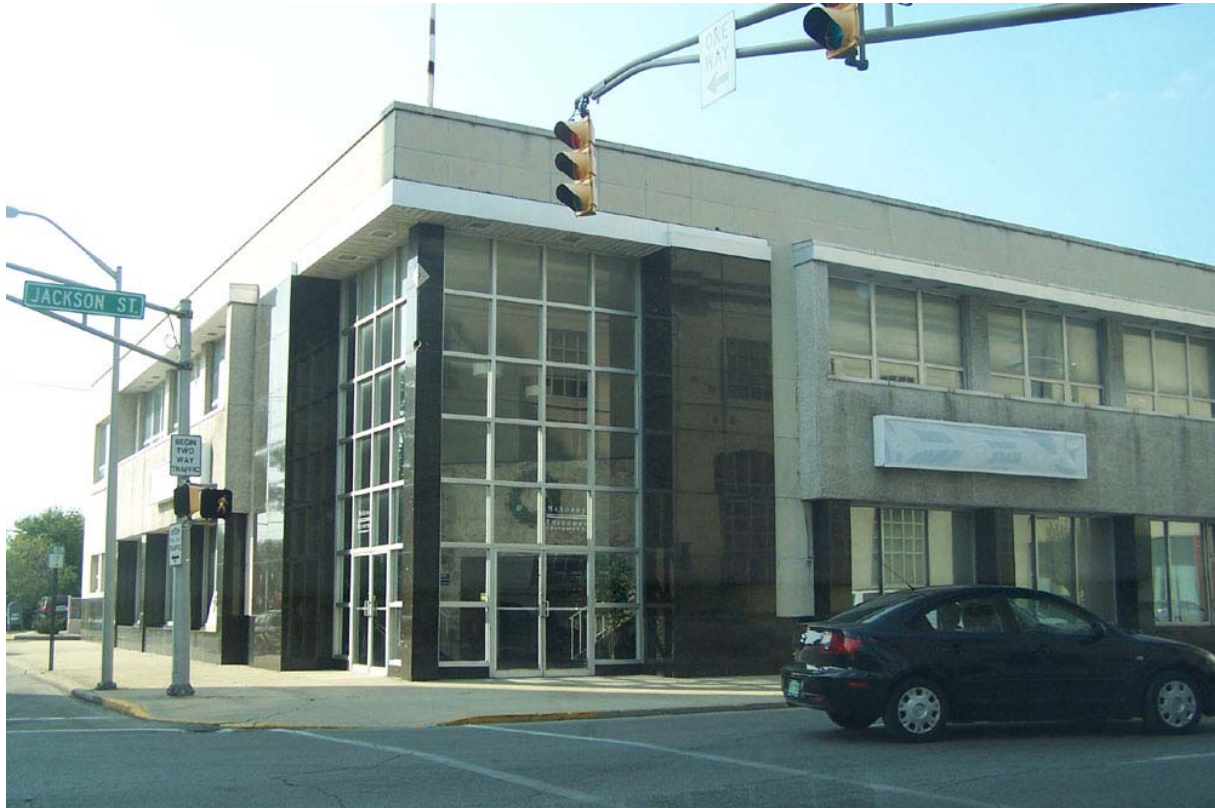
Photo 32

This two-story modern building is currently vacant and for sale. The most recent tenant was **Prudential Securities**. It is a Modern style, flat roofed, square building veneered with limestone and black granite. It features a glass corner entrance with four aluminum framed windows across by seven windows high, spanning from the ground floor to the top of the second floor with polished black granite piers at the corners and sides of the entrance area. There are double glass, side-by-side, commercial entry doors on both south and east entrances of the corner. A projecting frame of stone and granite holds three horizontal fixed windows, with aluminum frames dividing each fixed window into nine lites on the second floor and large

vertical lites on the ground floor. The building falls within the period of significance of the district and illustrates its ongoing development in the 1950s.

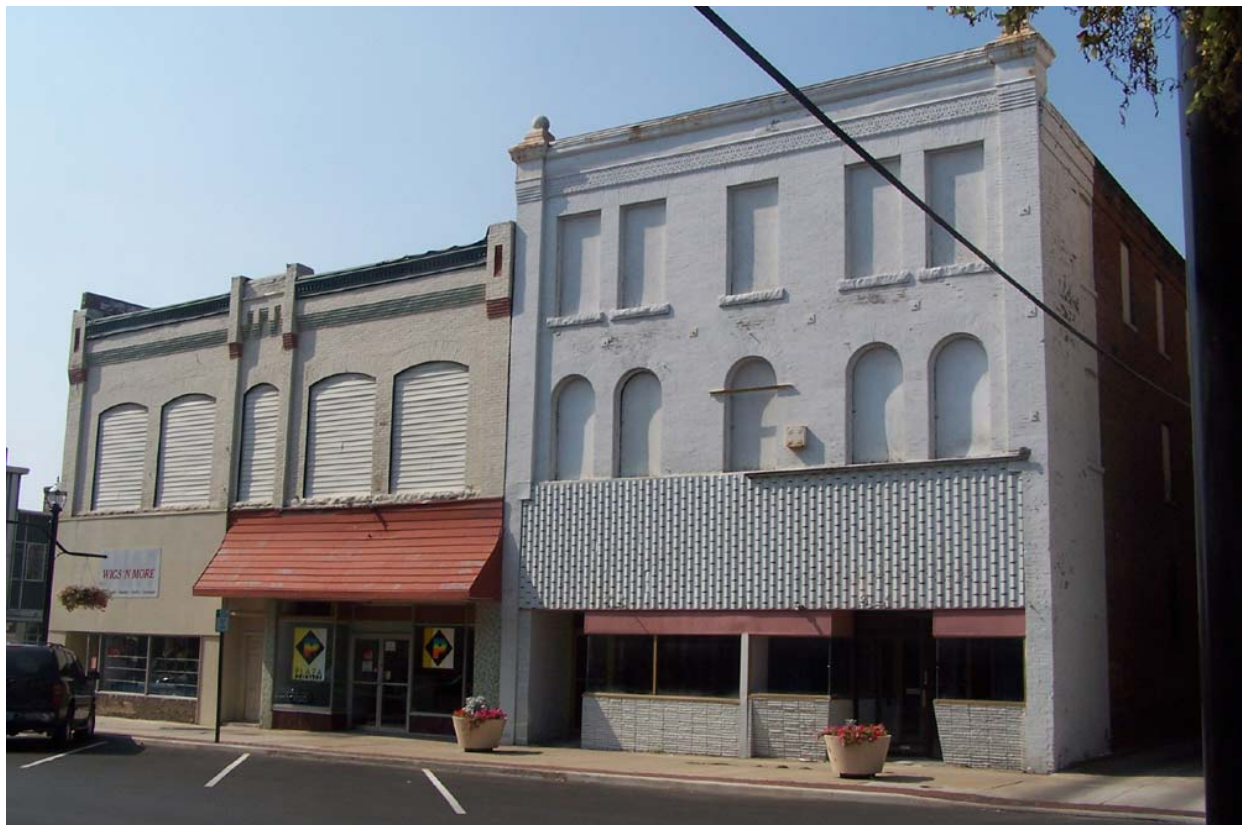
Photo 3

This three-story painted brick building is currently vacant. Most recently, a restaurant occupied the first floor, **Brickhouse**, for a short period. It has residential space on the 2nd & 3rd floor and retail or restaurant space on the first floor. The windows on the 2nd & 3rd floors have been boarded up with plywood. The 2nd and 3rd stories have 5 windows spanning across the top on each floor. The top floor's windows are rectangular with stone sills, whereas the second floor windows are round arch topped. They have all been boarded up. There are two stone finials located on each front, top corner of the building, framing the corbelled brick work cornice.

The ground floor is a recessed storefront entrance and one private entrance to the upper floors. The entrances have glass showcases across the lower levels that rest on approximately 4' brick bases. The lower portion was badly altered in the 1970's. The area between the ground level windows and 2nd floor has had a 1970's retro, variegated, metal designed façade added. Original materials may still be located behind this unoriginal material. Entry doors to both units are single glass & metal entry doors.

This building currently houses **Wigs & More & Plaza Printers** on the first floor and the second floor is vacant. The north unit has a recessed entryway, whereas the other is even with the overall building. Both have commercial glass doors, 1 single and 1 double. The building has been painted and the decorative features in the cornice have been painted to highlight the overall appearance of the building. An awning has been installed on one retail area and an internally lit plastic sign has been placed on the other retail area over the entrances.

There are five large segmental, multi coursed arched windows across the 2nd floor level with stone sills. The windows have been boarded up on the second floor. The center window is smaller in width than the other four. The building is separated into two units. The cornice is of corbel brick coursing and projecting piers marking the narrow center bay and ends of the building.

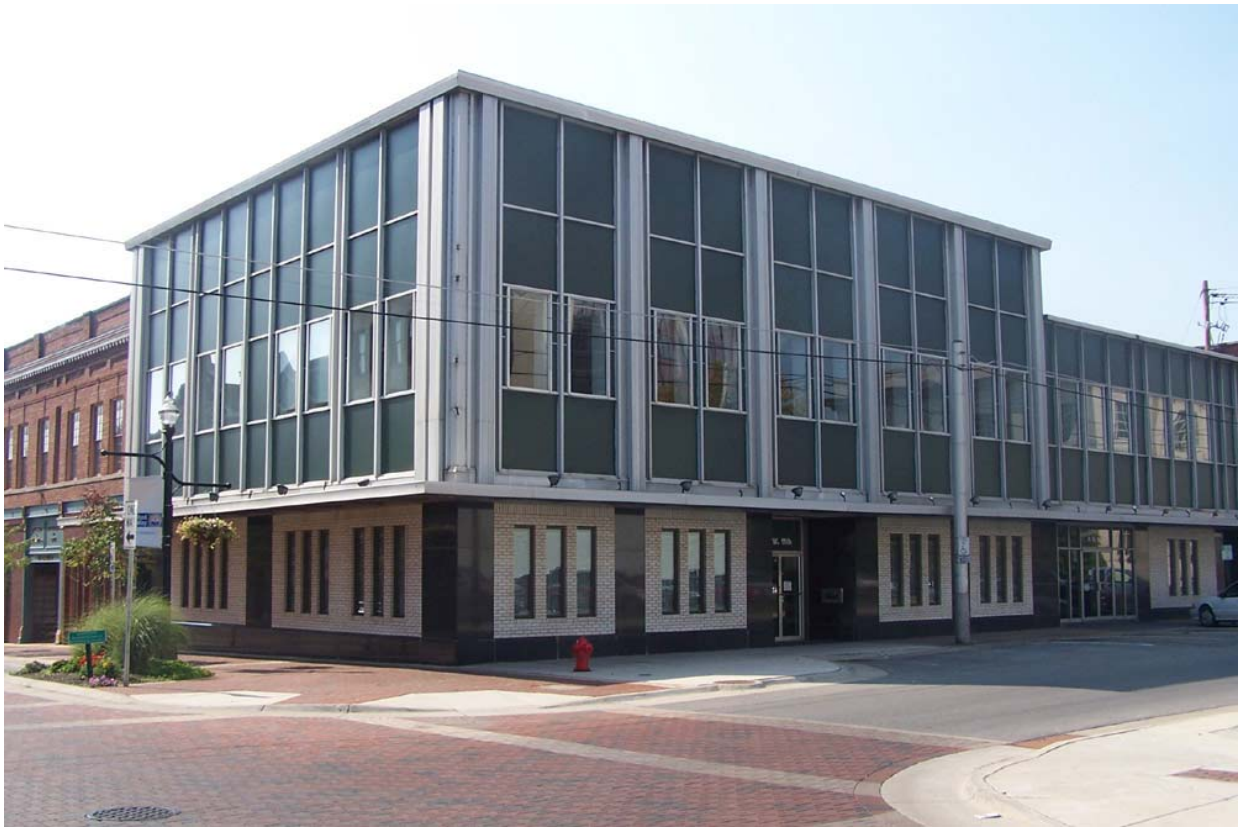
Photo 4

This building houses a combination of offices and vacant space on the ground floor. **The Madison County Historic Society** was recently deeded the building to house their artifacts. The upper two floors are used for storage and vacant at this time. This three-story building went through a radical rehabilitation in the 1970's and was covered with a green, metal façade. Metal, casement windows were installed across the

2nd floor level on the east and north sides. A local architect is developing plans to recreate its original appearance.

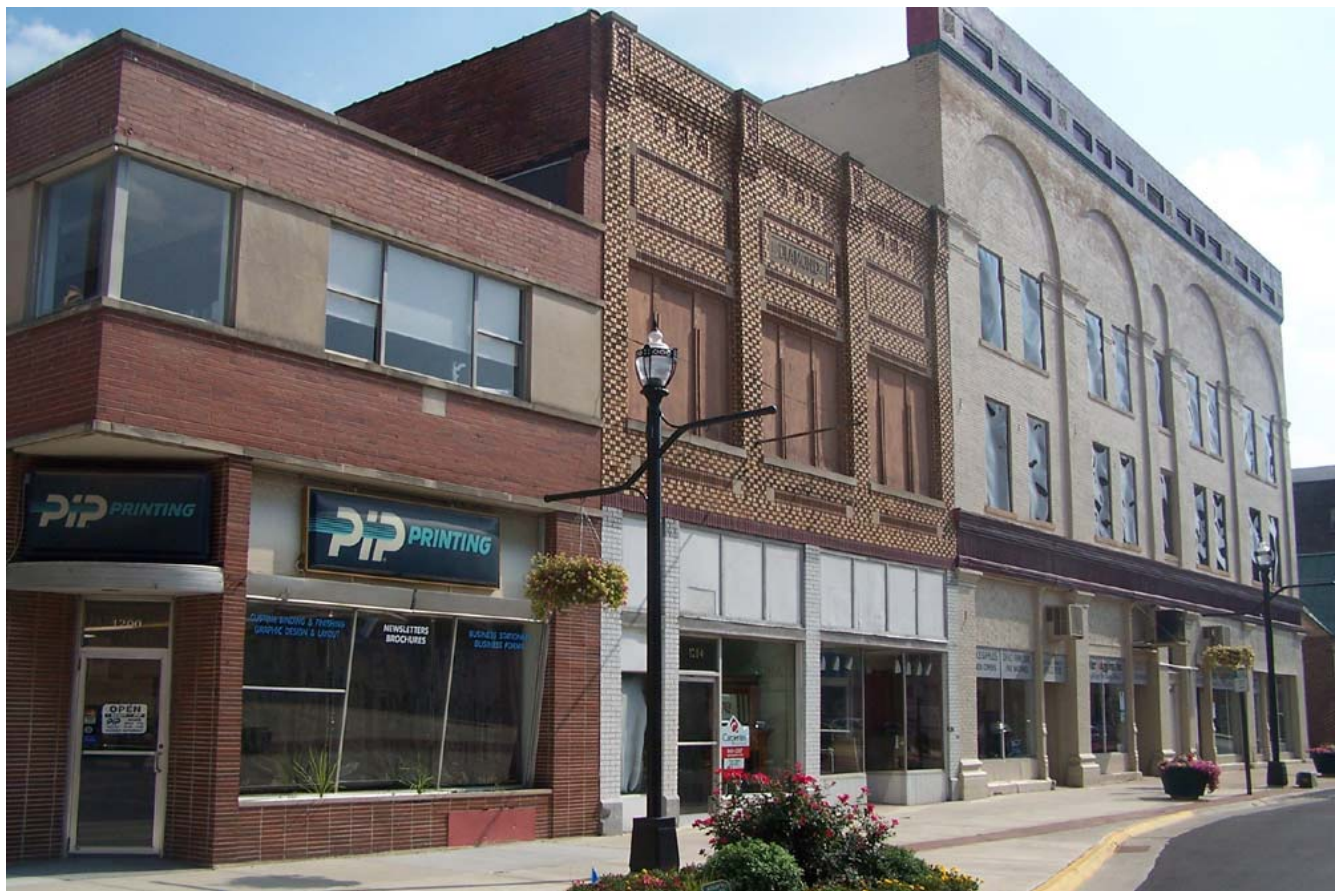
Photo 25

This building currently serves as a **PIP Printing Shop** downstairs and an architect's office upstairs. The structure is rectangular in footprint and has two stories. The primary building materials are brick, glass, and dressed limestone. This structure has a flat roof with slightly overhanging narrow coping. The second story has a series of 10 large single pane windows cased in metal. The second story has a corner window with aluminum corner mullion. On both sides of each large window are double hung single light windows also metal cased. Between each window grouping are limestone panels. Each panel is composed of two limestone sheets. The rest of the second story is composed of brick, and the second story cantilevers slightly over the ground floor. The first floor has its eastern half mostly composed of metal cased windows and doors. There are four of these glass doors on the eastern half of the first floor. On the western half of the first floor the exterior skin of the structure is limestone. This section has three boxed display windows. These windows are framed in limestone. The front of the first floor is composed of five large displayed windows and a glass door each cased in metal. The rest of the front is composed of brick.

Two story rectangular brick 3 bay structures. First floor has storefronts, which have been altered. The brickwork is laid with "Flemish bond" brick, a tan face brick imprinted with a pattern, so that when laid stretcher bond, the pattern makes the wall appear to be Flemish bond. Brick pilasters stand between window openings, the four pilaster strips rise from the top of the storefront level to the cornice. Second floor windows set in groups of 3 with fixed

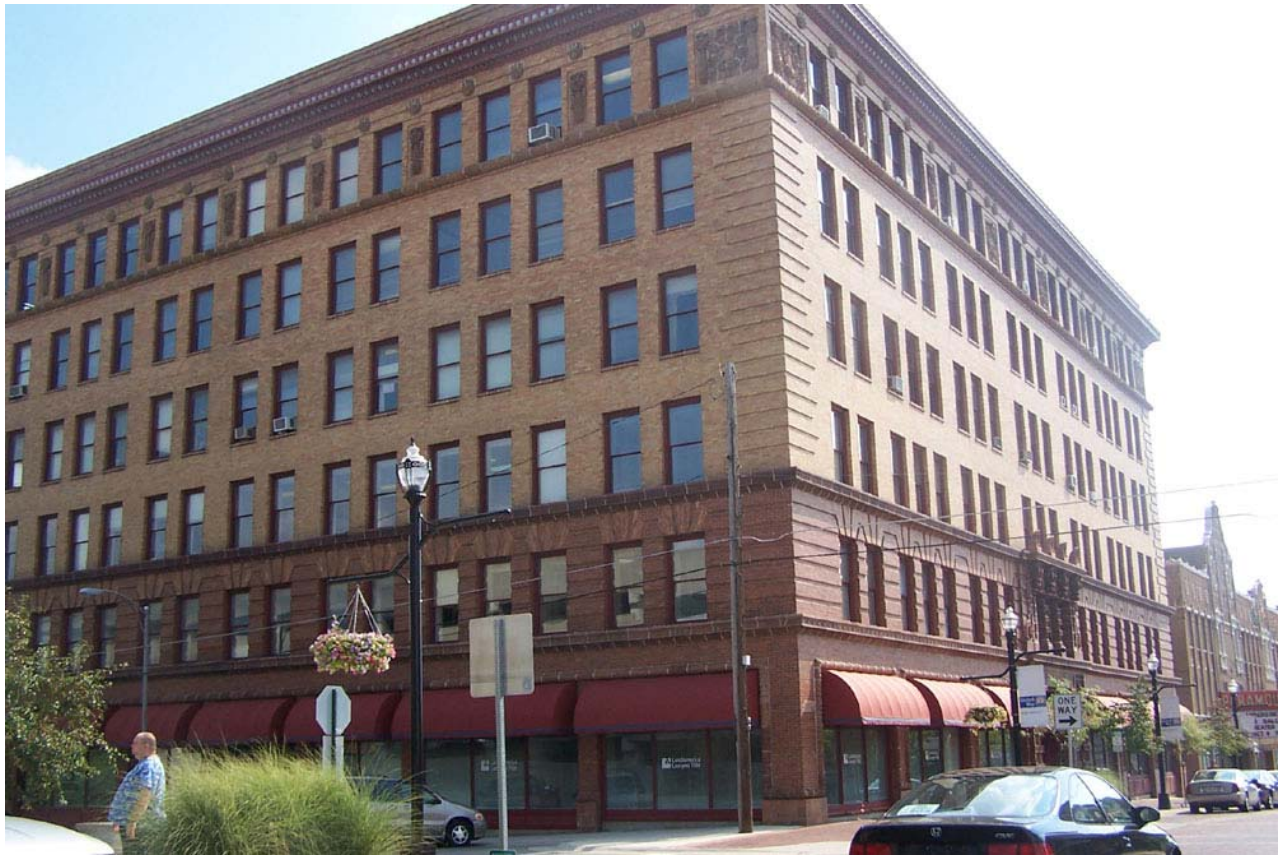
Photo 28

Six story rectangular building of 7 bays constructed of tan brick with red terra cotta details projecting cornice of terra cotta with egg and dart and dentils. Top story and third floor have terra cotta belt course at sill line in leaf pattern. Below cornice are 24 terra cotta medallions. At corners of top floor and between window groupings, which have a rhythm of 2-3-3-3-3-2, are terra cotta moldings. Corners have ring with a tassel ornament design. This same design in between window on 6th floor. All windows are ½ double hung. At corners of floors 2-5 are projecting bricks imitating a quoin design. The mezzanine is of red brick with a belt course at sill and lintel of 2nd floor. First floor has large store front windows, west façade with a center entrance. A curved metal canopy covers sidewalk and breaks window. Vertical board above projection. Stucco with small pebbles for bulkheads. Center entrance has 2 pairs of doors. Broken fluted engaged pilasters topped with terra cotta ornaments flank this. Union Building is inscribed above entrance. Over entrance on mezzanine are 3 1/1 double hung windows with rusticated engaged columns flanking center window. Terra cotta designs flank outside windows. Terra cotta brackets and acroteria top these terra cotta divisions. Above each window is an inscription broken by the brackets. The inscription is “ANNO”, MDCDII.” “DOMINI”. North side of building has 7 bays with entrance at far left.

LOBBY: Tile floor with fret design in black and white. Marbleized walls with coat of arms bearing a “V”. Recessed paneled ceiling with dentil and egg and dart design. Dropped fluorescent lights. Lobby altered for elevators. Stairway to right is narrow, with wood and iron railing. Brass globed five lights at newel post.

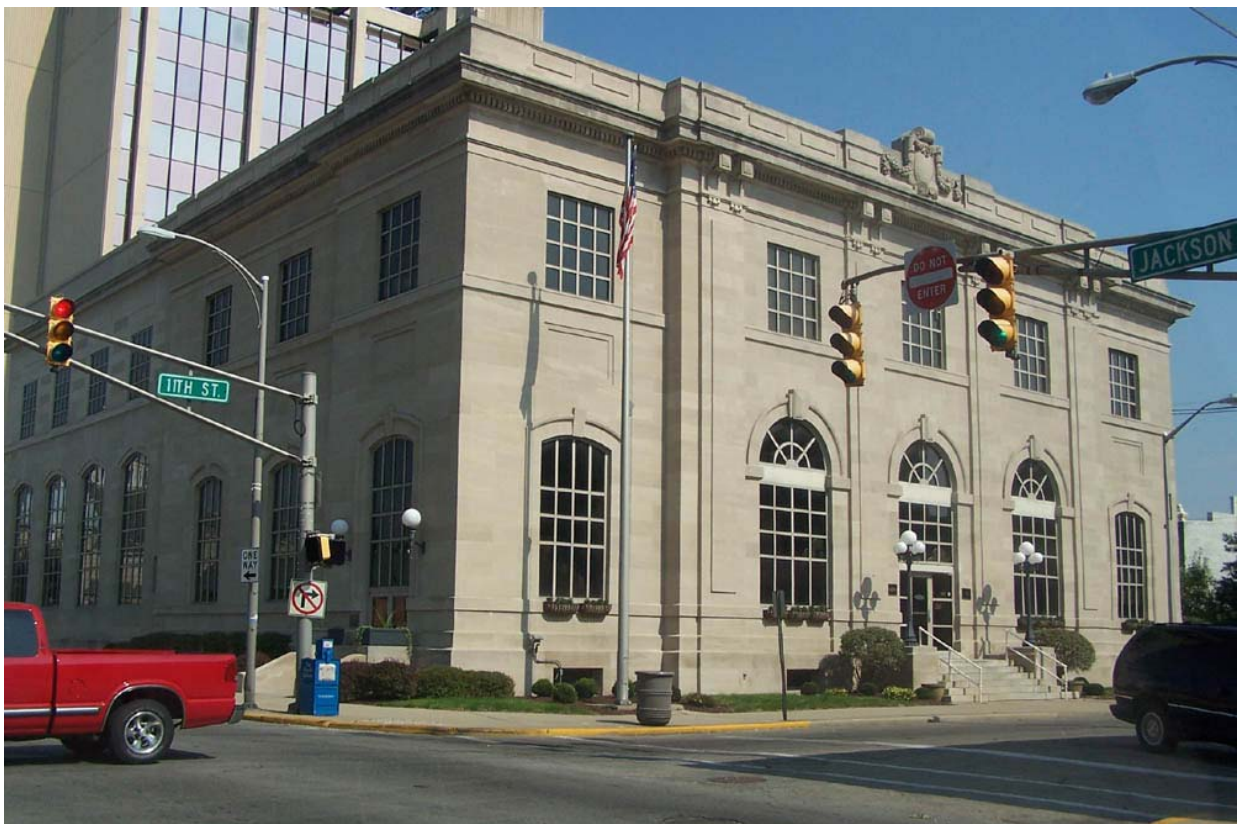
Photo 33

This building currently houses the administration offices for **Ricker Oil and KR Montgomery Architectural Services**. The building is rectangular in plan and 2 stories in height. It is of dressed limestone with five bays along the front façade. It is topped with a Neo-Classical cornice, which is ornamented in the center with a garlanded oval shield. Below this is a dentilled course with recessed panels. The three bays in the center are defined by engaged pilasters, which are topped by large paired brackets. The windows in the center bays have round arched fanlight transoms with stone surrounds and keystones. A belt course separated the first and second story. Second story windows are paired 4 over 4 double hung, square proportioned windows. On the first floor the outer windows are set in segmental arched openings with two-light transoms over paired 4 over 4 double hung windows.

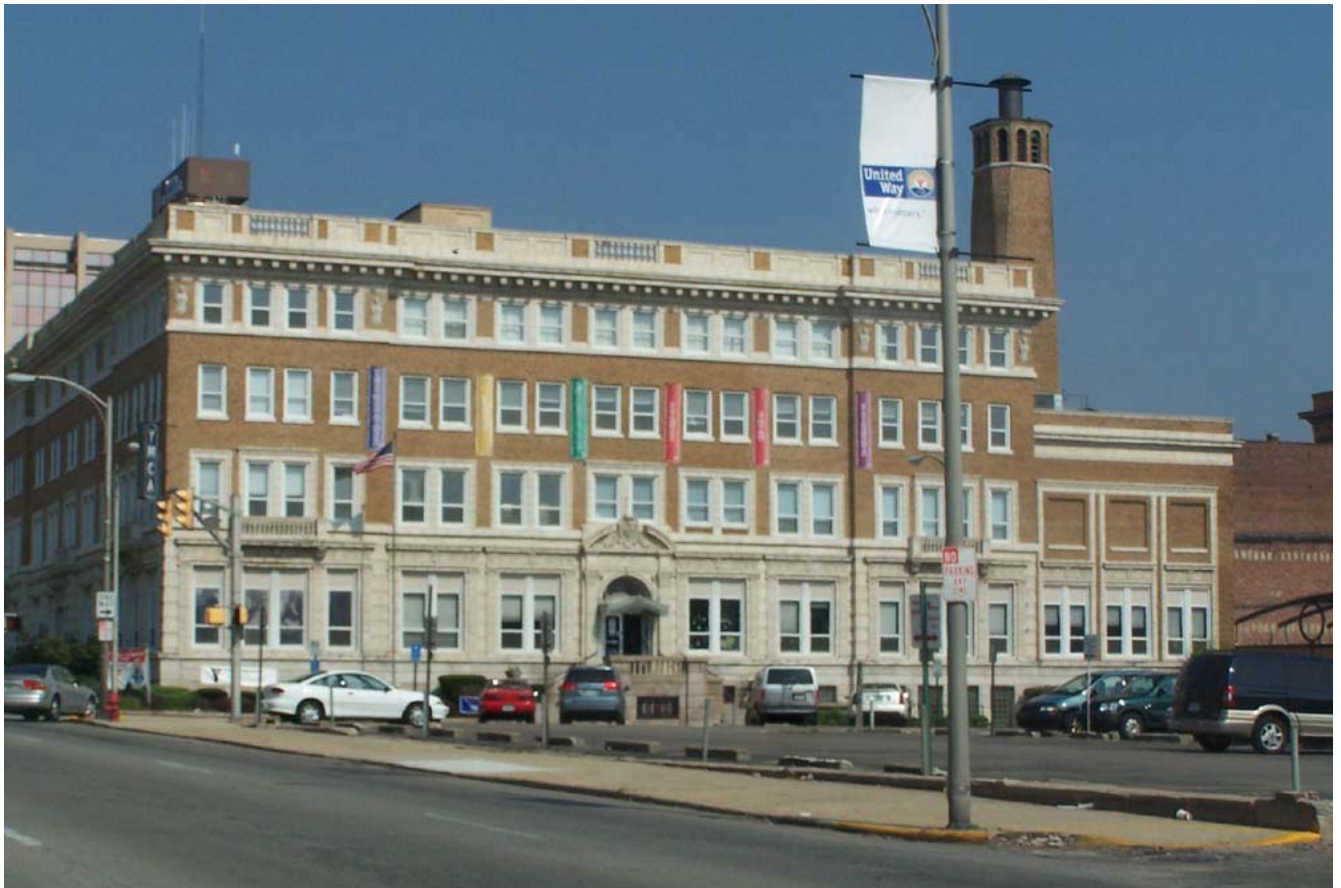
Photo 36

The **YMCA** currently utilizes 100% of this building. It is a square brick building of 4 ½ stories with buff brick walls and terra cotta details. End sections project slightly forward and have four bays; the center section has five bays of double windows, the center bay is the entrance. Cornice has dentils and egg and dart designs with a classical balustrade with panels and open balusters. Terra cotta cupids above a shield bearing a cross are on the flanking projecting sections. Terra cotta also surrounds 2nd and 4th floor windows. All windows are 1/1 double hung. First floor has terra cotta griffins below 2nd floor balconies with flowers, urns and cupids on top. First floor windows are fixed. There is a limestone water table with YMCA symbol carved at corners. Entrance has a shield with YMCA symbol above a broken segmented pediment with floral designs. Fluted pilasters with Corinthian capitals and female faces in relief flank the round arch opening. The double doors are metal. A metal grillwork fills the arch. Below this is a curved arched metal canopy with the supporting brackets attached to lion heads. Side stone steps and balcony rail lead to the door. Basement windows open below upper floor windows. Wings of the building match in materials, however, terra cotta designs above windows have winged mermaids instead of griffins. There is a lower section to the east, behind it is an original boiler stack, architecturally disguised as a lighthouse-like structure.

This building has a Modern extension that was constructed in 1974 located at 28 W. 12th Street and is used for the indoor pool area. It is a square, brick building with two columns of 5 windows on the far east side facing 11th Street. There are no entrances on this portion, (besides emergency exits). There is a decorative brick band along the top portion of the building and a plastic sign, designating the Y.
